J Occup Environ Hyg. 2014 ; 11(11): D200–D207. doi:10.1080/15459624.2014.955182.

An Evaluation of an Aftermarket Local Exhaust Ventilation Device for Suppressing Respirable Dust and Respirable Crystalline Silica Dust from Powered Saws

U.S. DEPARTMENT OF HEALTH AND HUMAN SERVICES (DHHS), Public Health Service (PHS), Centers for Disease Control and Prevention (CDC), National Institute for Occupational Safety and Health (NIOSH), 4676 Columbia Parkway, R5, Cincinnati, Ohio 45226

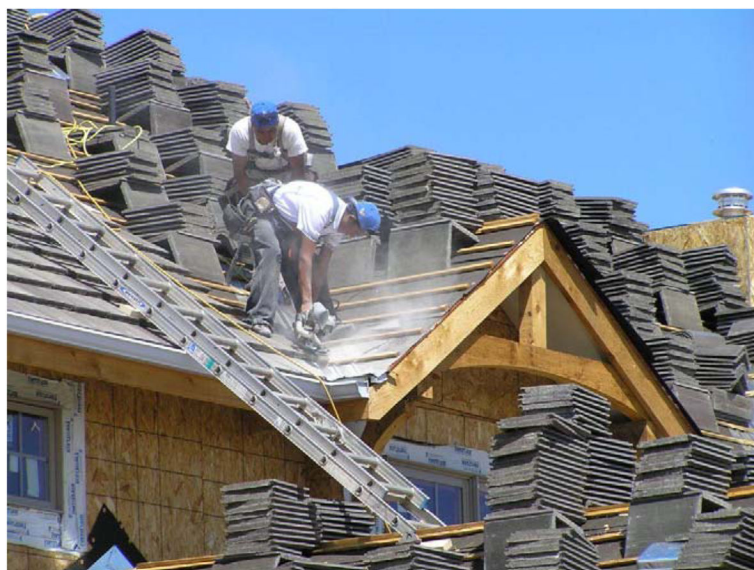
Figure 1.
Roof arrangement while installing tiles

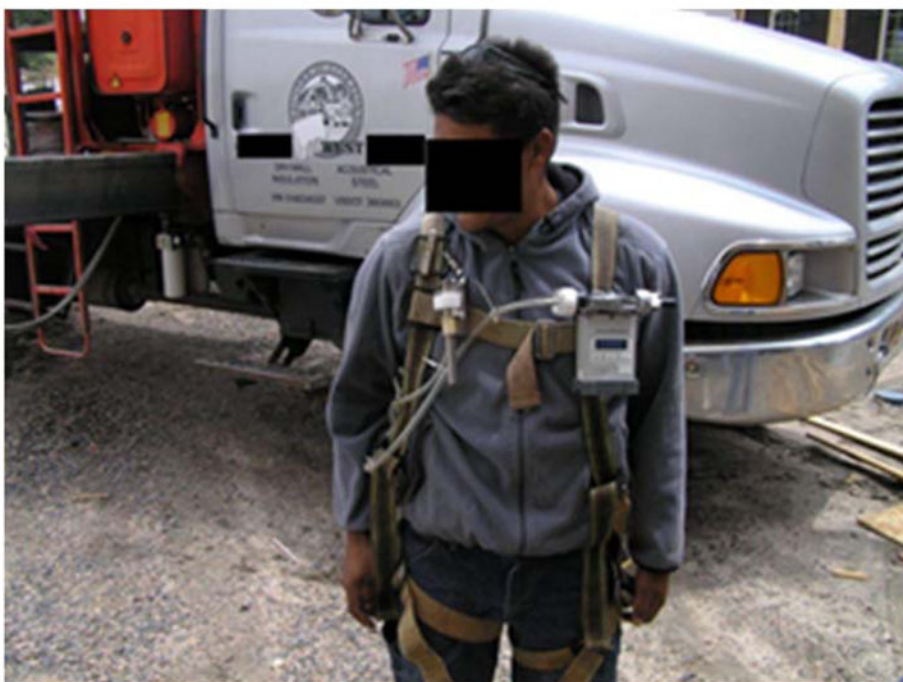
Figure 2.
Cutter/Roofer wearing the sampling equipment

Full-shift sampling was conducted to determine the respirable dust and silica exposures of two roofers and two cutter/roofers at each site. Personal breathing zone samples (PBZ) were collected on 37-millimeter (mm) diameter Polyvinyl chloride (PVC) filters with a 5-micrometer pore size at a flow rate of 1.7 liters per minute. A 10-mm nylon cyclone pre-selector was used to limit the collected particles to respirable sizes.

Additionally, for the two cutter/roofers that were mainly responsible for cutting the tiles, direct reading PBZ respirable dust sampling was conducted concurrently using an active sampling portable laser photometer (MIE personal DataRAM model pDR1200, Thermo Electron Corporation, Waltham, Massachusetts). The direct reading instruments were up-to-date on calibration and were zeroed at the beginning of each sampling period according to the manufacturer's recommendations. Downstream from the photometer, a 37-mm PVC filter with 5-micrometer pore size was fitted connected via Tygon® tubing to a sampling pump calibrated to a flow rate of 2.2 liters/minute to provide simultaneous collection of the analyzed dust. By fitting the photometer with a BGI4L metal cyclone (BGI Inc. Waltham, Massachusetts) dust pre-selector, a calibration filter was used to determine the concentration of sampled respirable dust (Figure 2). This was conducted to compare real-time and filter-based exposure estimates and to calculate the respirable silica content of the real-time exposures. Real-time sampling was stopped during the workers' lunch break to limit the analysis to time spent performing roofing activities. The filter samples from the photometers were analyzed for respirable dust and for silica using the modified NIOSH analytical methods discussed previously.

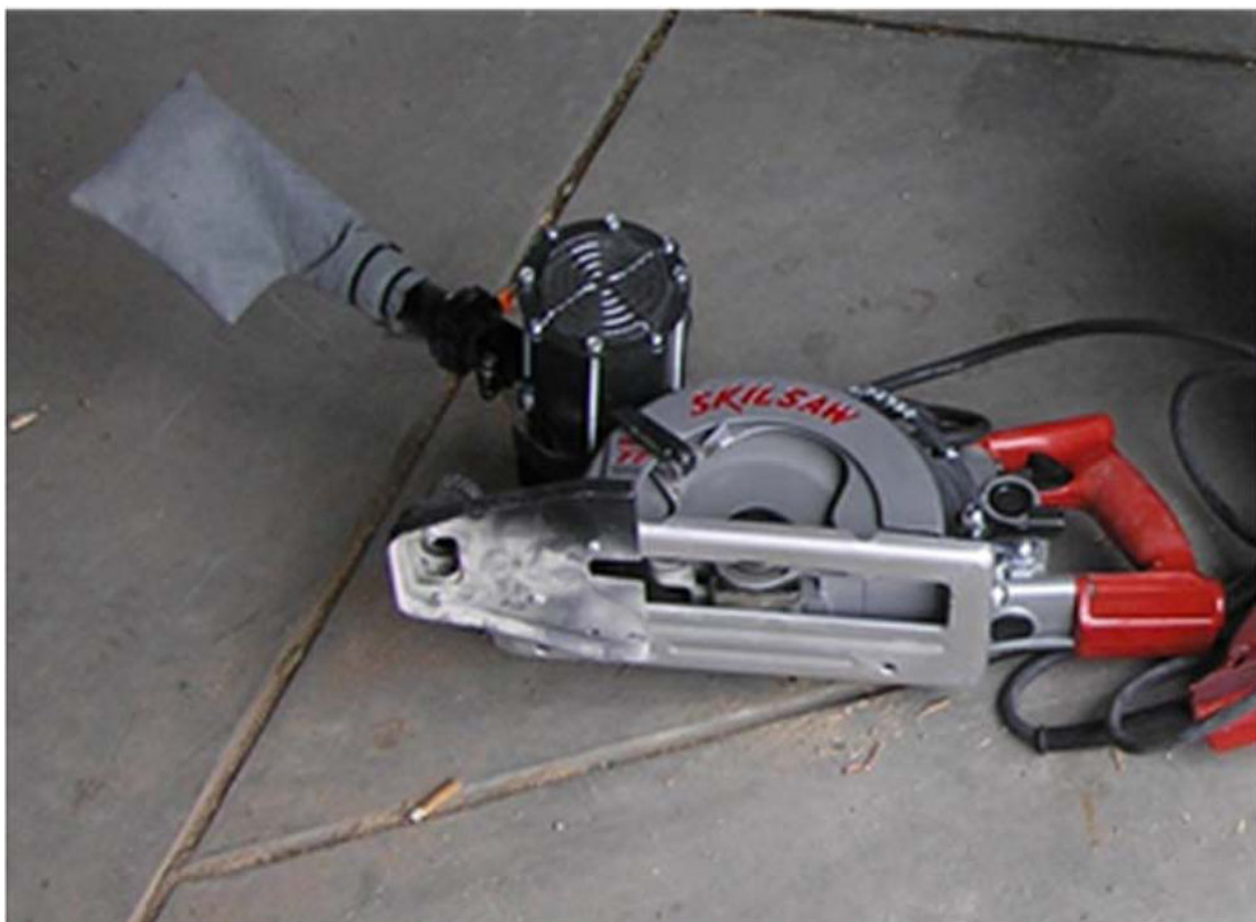
Figure 3.
Circular saw with aftermarket local exhaust ventilation

This study evaluated the exposures when using a 7–1/4 inch worm-drive electric circular saw (model hd 77 m, Skil®, Ontario, Canada), with aftermarket LEV installed. The LEV consisted of a shroud attached to the cutting plane of the saw; the shroud was then connected to a small electric axial fan (Pneo model 77 mag), which is intended to collect dust at the point of generation (Figure 3). After passing through the fan, the dust is collected on a cloth bag which also serves as a filter media. Periodically, the bag would need to be emptied or replaced as it filled with dust. The bag material was laboratory tested by NIOSH using a characteristic aerosol typically used for testing respirator filter media efficiency. The aerosol size is within the most penetrating size range for respirator filters. When tested, the LEV control bag had penetration values between 55% and 61% over a flow rate range of 80 – 100 liters per minute.

The dust collection system was activated automatically when the trigger switch on the saw was depressed, and shut down when the trigger was released. The local exhaust ventilation was installed as a permanent attachment which added to the weight of the tool. In addition,

the installation of the dust collector required the saw to be used by the worker pulling the saw toward himself, necessitating the removal of the lower blade guard.

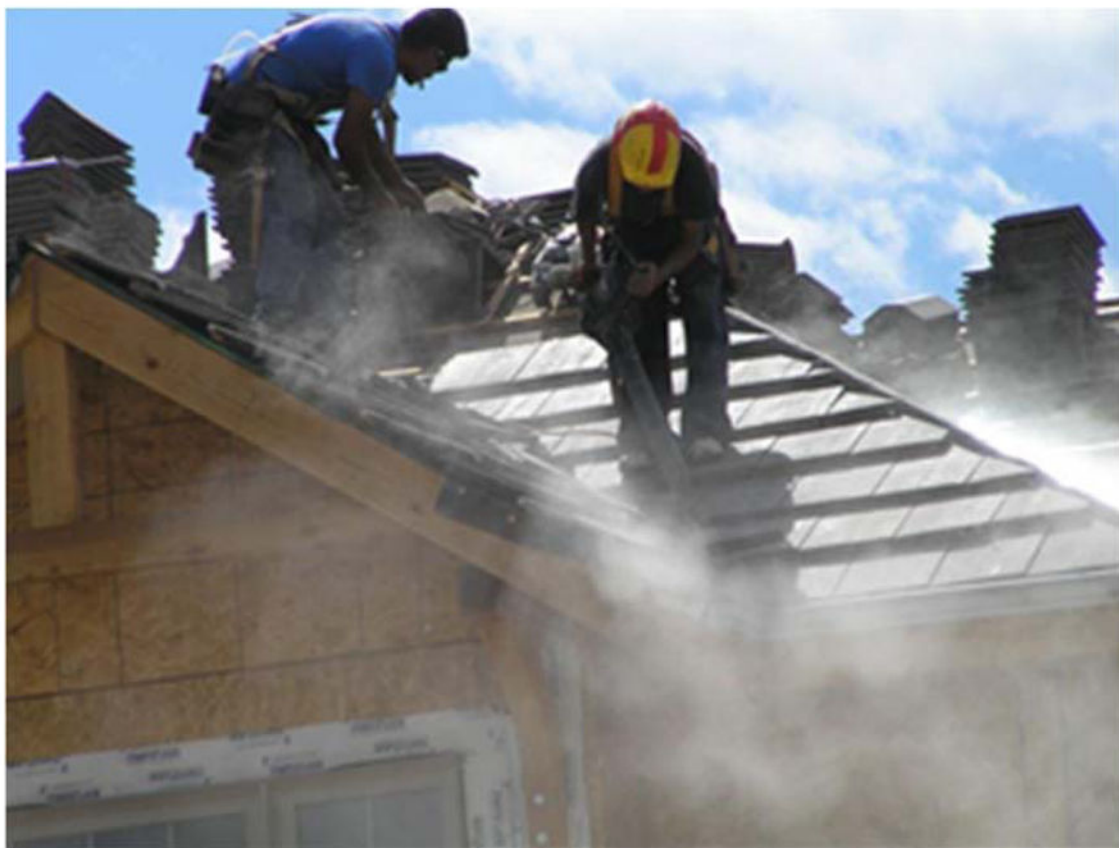
Figure 4.
Workers using a leaf blower to clean dust from tiles

The video exposure monitoring images displayed more visible dust during tile cleaning than tile cutting, but the real-time monitoring indicated that higher respirable dust concentrations were observed during tile cutting. Also, the leaf blower is used to remove settled dust which will tend to have a larger particle size, hence the lower respirable concentrations.

As mentioned in the results and discussion section, a leaf blower was used to remove dust from the tiles. This process should be carefully reviewed as it creates an unnecessary exposure to all employees, whether they cut or lay the tiles. Alternative means of cleaning the tiles without making particles airborne should be used. The use of manual roofing tile cutters has proven to reduce exposures below the OSHA PEL and the NIOSH REL. Further investigation of manual cutters or improved local exhaust ventilation should be conducted. The results reported here indicate that workers should use respiratory protection when they are using the saw and/or the leaf blower.
